ECOSPEED®

SHIP HULL PERFORMANCE TECHNOLOGY

Magazine

Ice-strengthened research vessel given lifelong Ecospeed protection.....	3
Eliminating rudder cavitation damage.....	8

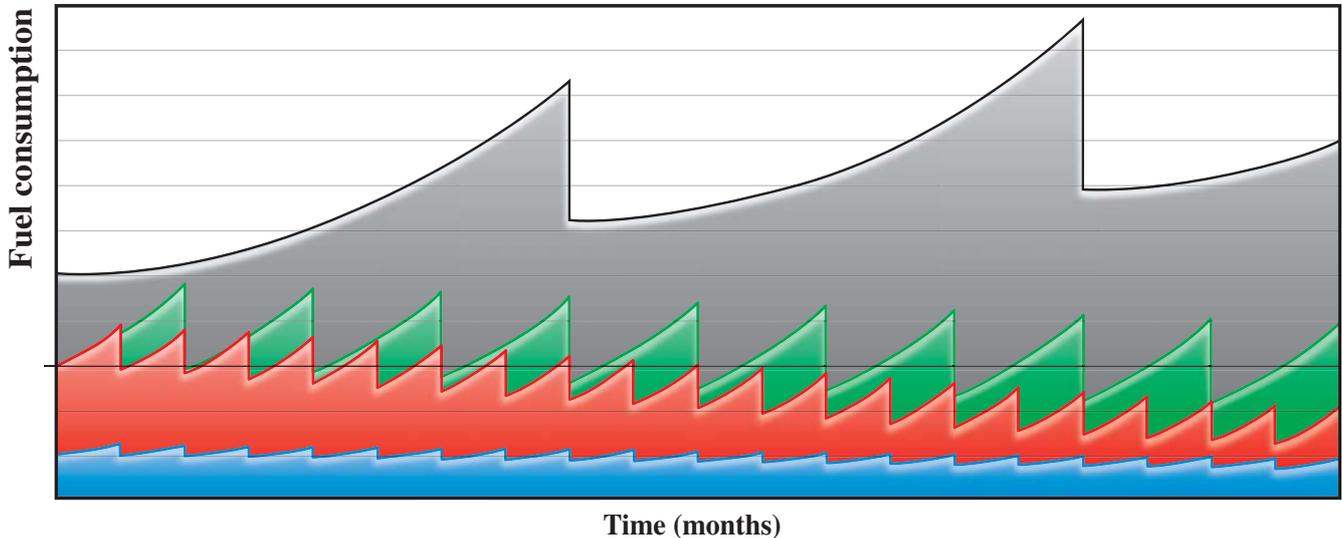
Development of additional fuel consumption over time

- Ecospeed with 2 cleanings per year
- Ecospeed with 4 cleanings per year
- Ecospeed with optimum cleaning intervals
- Active antifouling paints

Most ships sail with a chartering contract that includes a penalty clause if fixed distance/fuel consumption ratios are not met. However, this is unpredictable with regular paint systems and will also worsen over the years. The ship becomes more expensive and profits are reduced.

not only keeps the ship's performance stable but even improves it with repeated underwater maintenance. The coating is designed to be cleaned routinely with specially designed underwater hull cleaning tools. These simultaneously clean and improve the smoothness of the paint surface. This avoids penalties as well as producing enormous fuel savings.

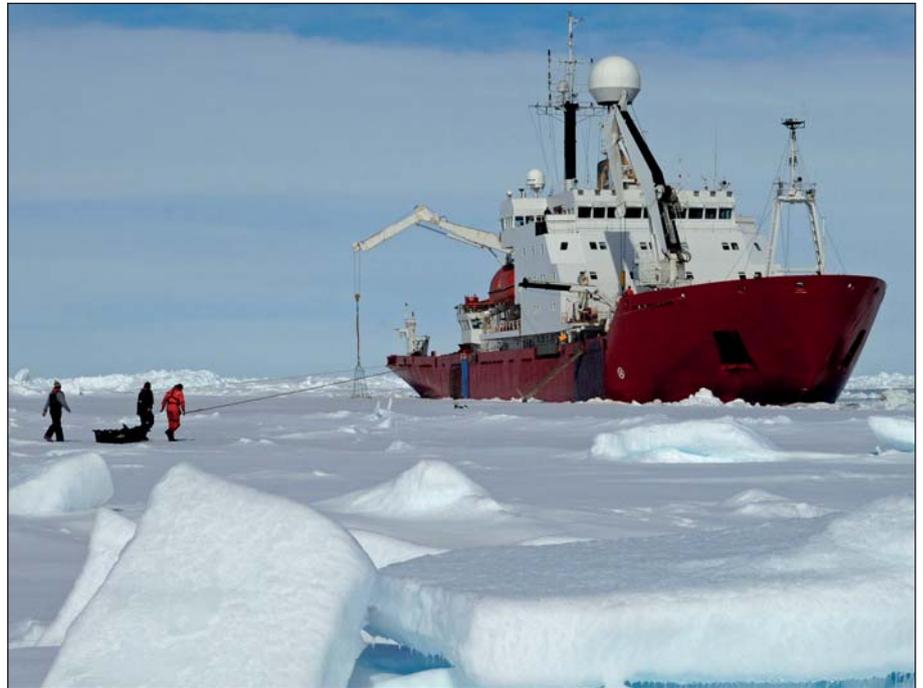
RRS James Clark Ross moored in sea ice in the Weddell Sea, Antarctica. Scientists can be seen returning to the ship following deploying IMB (Ice Mass Balance) buoys.

In August the bow area of the underwater hull of Royal Research Ship (RRS) *James Clark Ross* was coated with Ecospeed in Frederikshavn, Denmark. The ship is one of two ice-strengthened research vessels operated by British Antarctic Survey (BAS).

This excellent result led BAS to coat the bow area of RRS *James Clark Ross* with Ecospeed. The vessel can steam at a steady two knots through level sea ice one meter thick. The bow area has to endure a constant impact with the ice and needs the best possible protection. Ecospeed low friction coating demonstrates excellent attachment to the hull and successful resistance to extremely icy conditions. The coating has proven an ability to withstand the harshest winter conditions on nu-

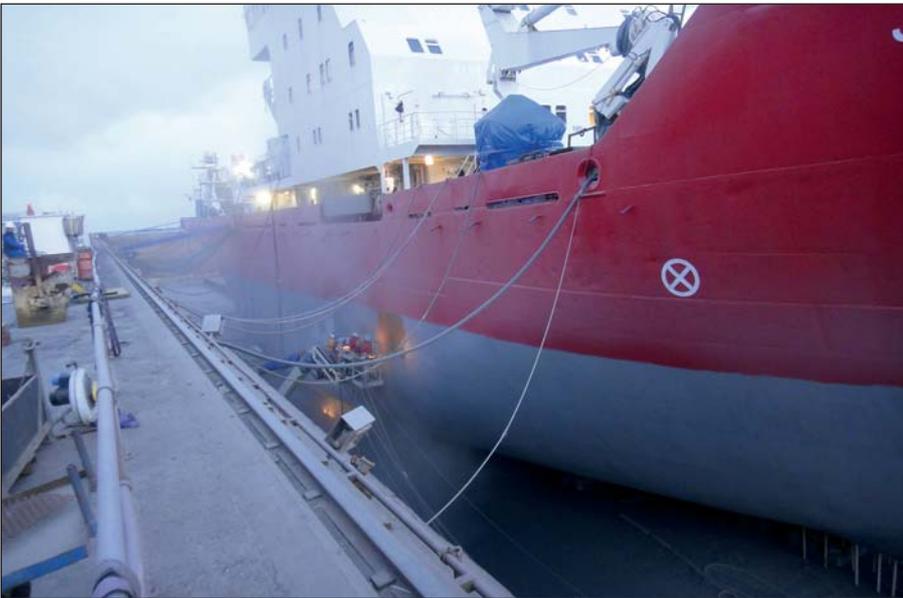
Surface preparation prior to Ecospeed application.

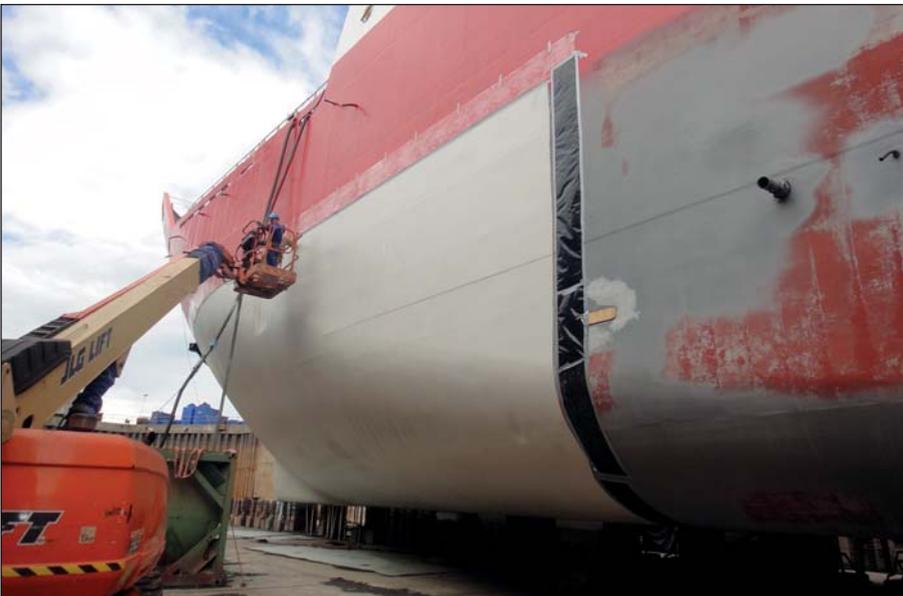
Application of the first layer.

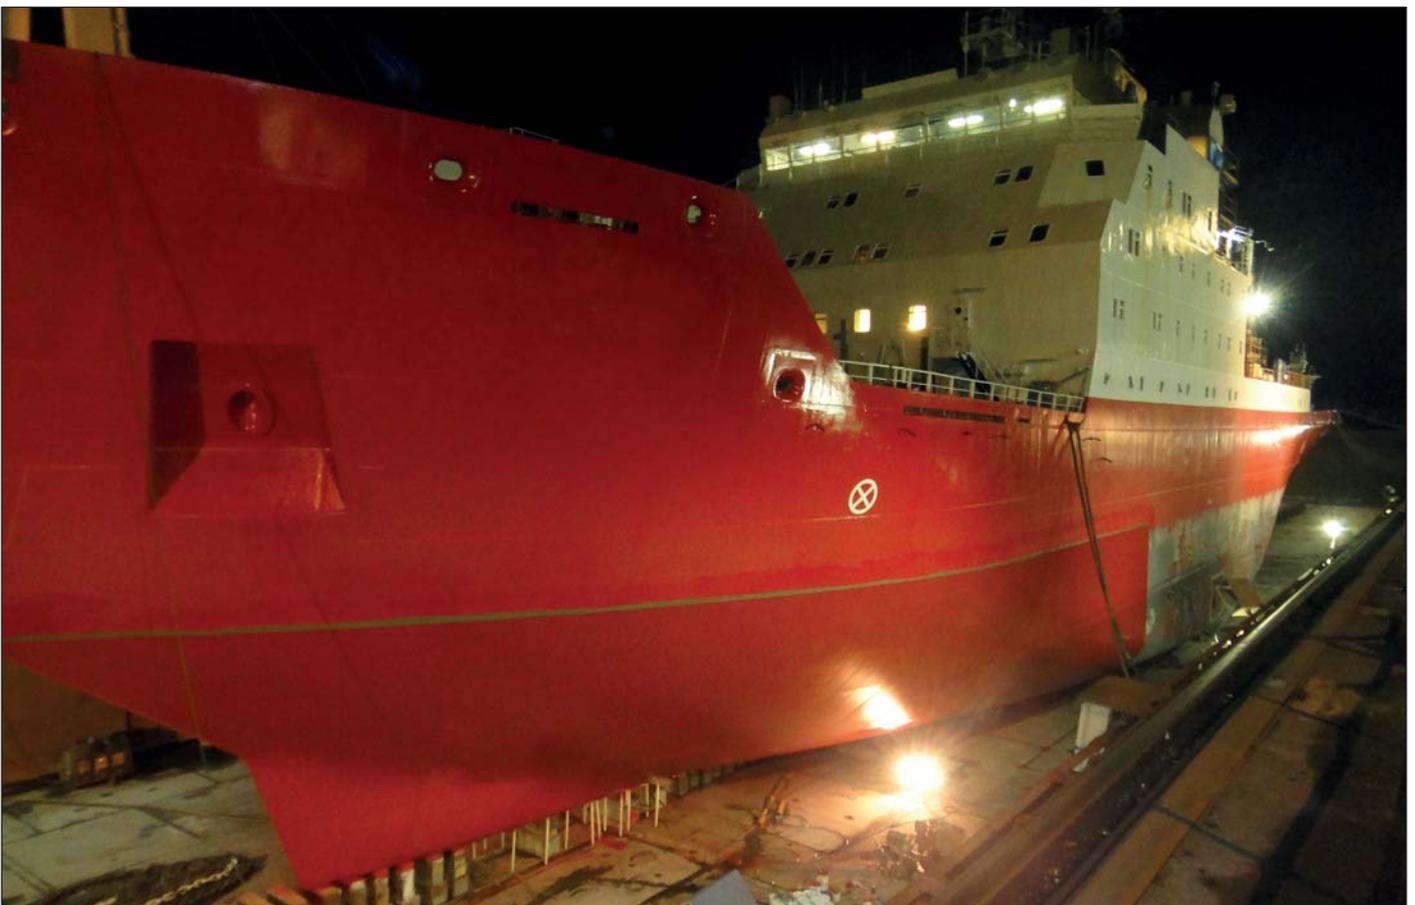
The bow area of RRS James Clark Ross will be protected for the rest of the vessel's service life.

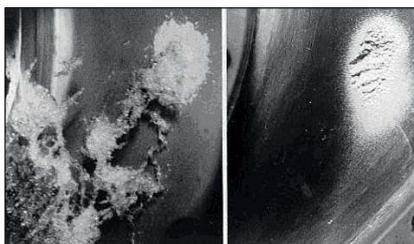
Cavitation bubbles and resulting damage.

Hydrodynamic cavitation is a phenomenon that accompanies turbulent fluids. The turbulence in the fluid, caused by the ship's motion through the water and particularly by the action of the ship's propeller, results in areas of greatly reduced fluid pressure. Due to the low pressure, the water vapourises. This creates small, vapour-filled cavities or bubbles in the fluid up to about 3mm in diameter. The cavities travel through the water and the pressure around them increases, causing them to suddenly collapse. The implosion of the cavities is accompanied by a

complex set of physical processes. It is the collapse of the cavities and the attendant high pressure pulses, speeds and temperatures in the water that cause the damage.

The forces involved are very large. It is as if the surface affected has been subjected to repeated, heavy blows from a hammer accompanied by high temperatures. This causes what is known as cavitation erosion as the surface material, first paint and then steel, begins to flake away. The process can be greatly magnified by the presence of gravel or other hard particles in the water.

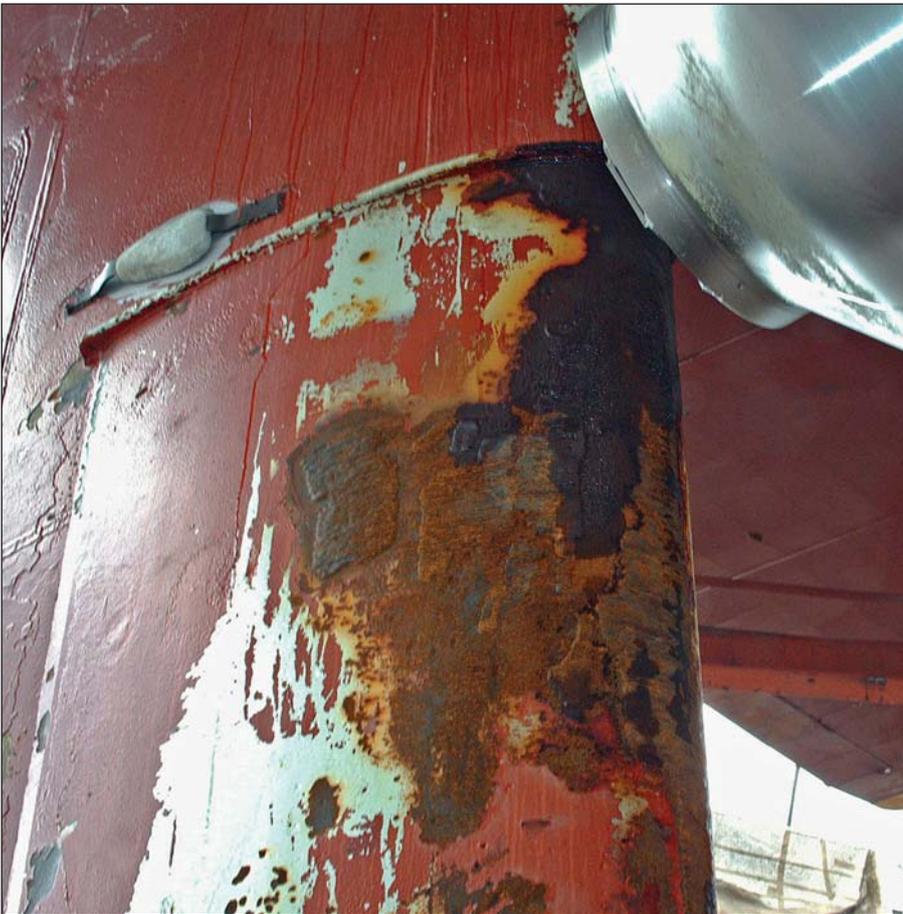
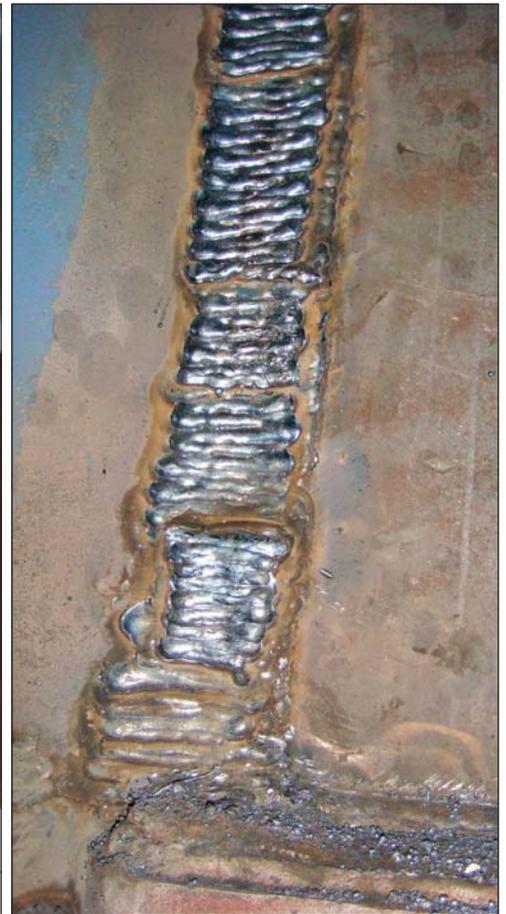
The damage caused by cavitation (left) and a typical welding repair (right).

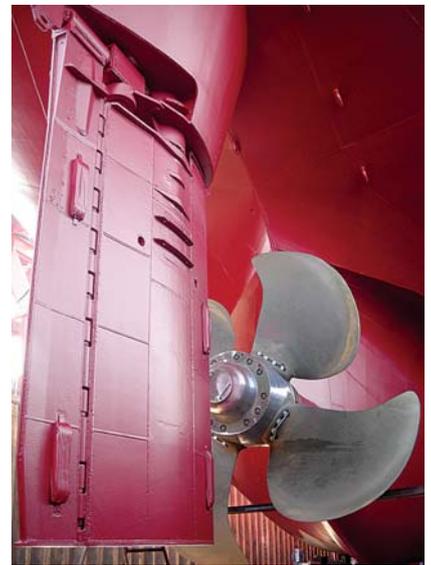
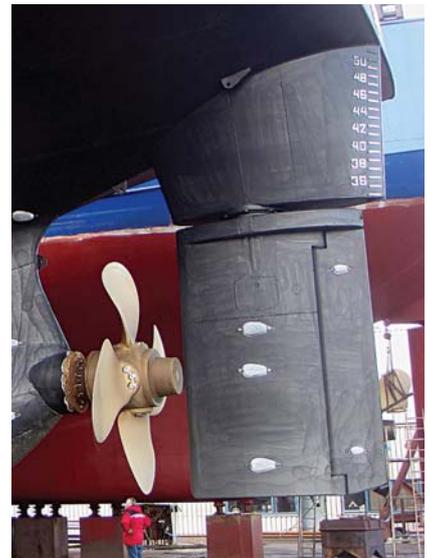
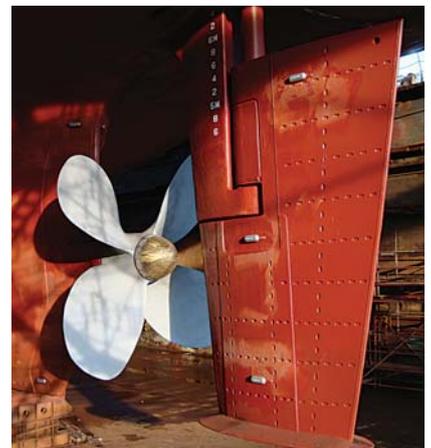
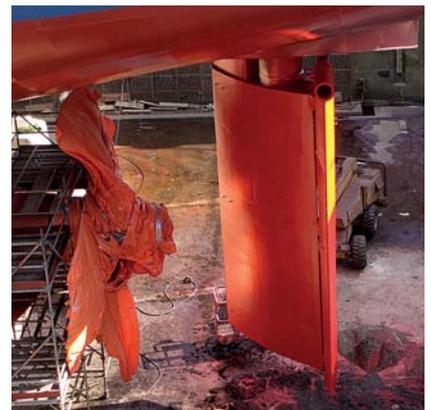
The rudder of the Maersk Diva after five years in service with conventional rudder coating (left), and five years after Ecoshield glassflake rudder coating was applied.

There is a type of coating that has been in use on rudders and ships' running gear for about ten years and has proven to be “cavitation-damage-proof” on the rudders to which it has been applied. Aside from some minor touch-ups, none of the rudders that were properly prepared and coated have had to be recoated, even after nearly ten years. None have suffered from cavitation damage since the coating was applied. For

those shipowners and operators who have tried this coating for their rudders, the cavitation damage problem ceased to exist. It is a specially formulated, glassflake-reinforced coating. One such coating is Ecoshield, supplied by Subsea Industries in Antwerp, Belgium.

In terms of preparation and application requirements, the coating is not particularly demanding. The surface must be grit-blasted to remove any previous coating and create an adequate anchor profile and clean surface. Either on newbuildings or when an existing coating is being replaced, two coats about 500 microns thick each are applied, adding up to a dry film thickness (DFT) of at least 1,000 microns.

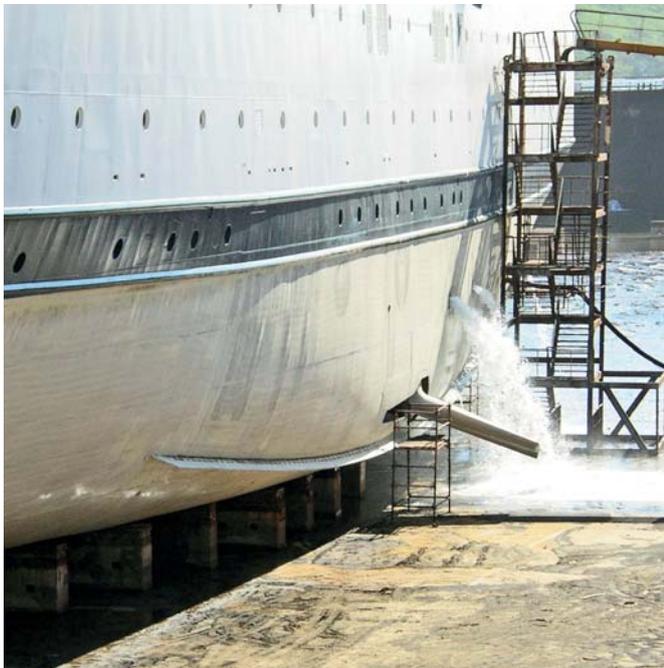
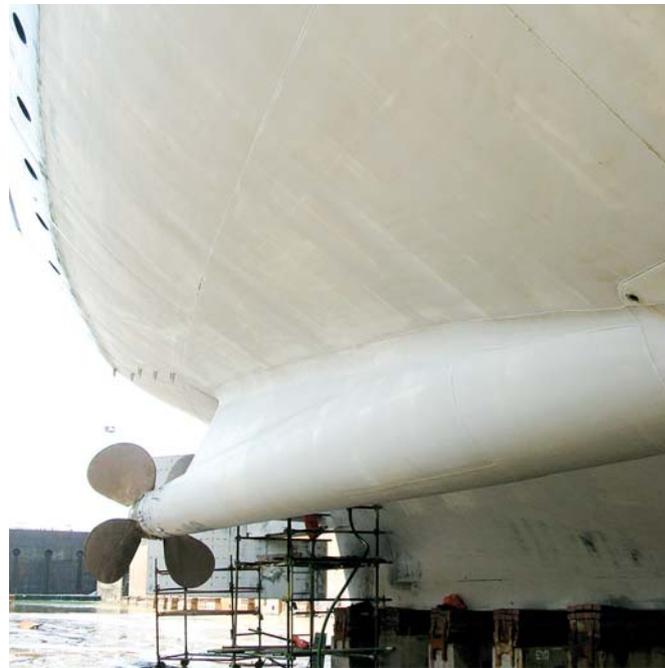
Hull of cruise ship after 5 years with Ecospeed coating with no replacement or major repair. This is the state of the hull when the ship came out of the water, without any cleaning or touch-up in drydock.
