Ecospeed for Polish research vessel

Viking's longship modifications

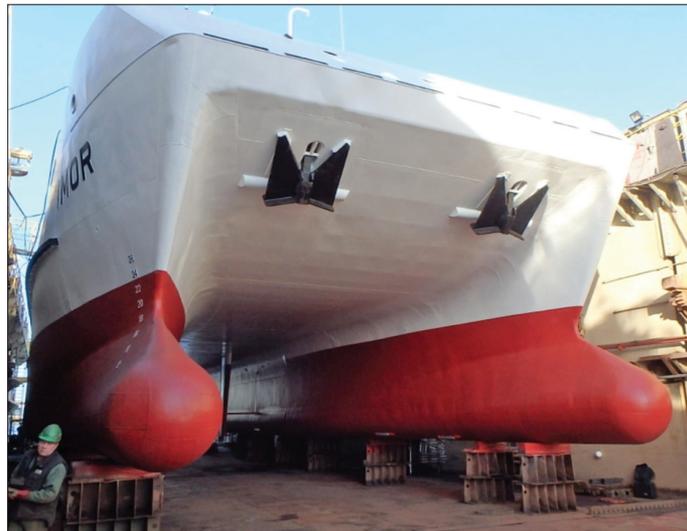
The "RV Imor" was built in 2005 as a multi-purpose shallow water survey and ROV support vessel

The *RV Imor* was built in 2005 as a multi-purpose shallow water survey and ROV support vessel. She can be easily re-configured according to the requirements. The small size, small draught, high relative power and great flexibility of possible applications makes her ideal for work in shallow waters.

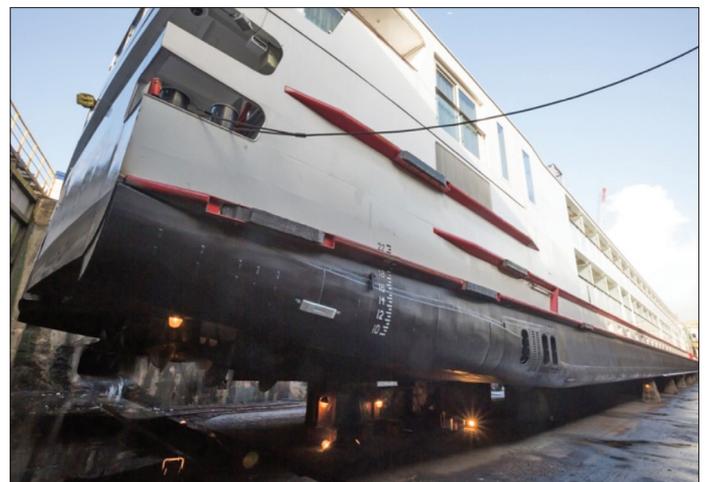
All the Longships require stern frame modifications

The primary scope of work for all six longships comprises stern frame modifications necessary to prevent propeller damage during turning manoeuvres in canals and other narrow waterways. The solution is to install an additional steel

construction reaching from the seawater inlet chest all the way to the stern. To reduce the time spent at the yard, Damen is prefabricating the steel components in advance.
