WHITE PAPER

Rudder Cavitation Damage Solved

**How to put a permanent end
to costly, repeated rudder repair
and replacement**

The Hydrex Group
www.hydrex.be

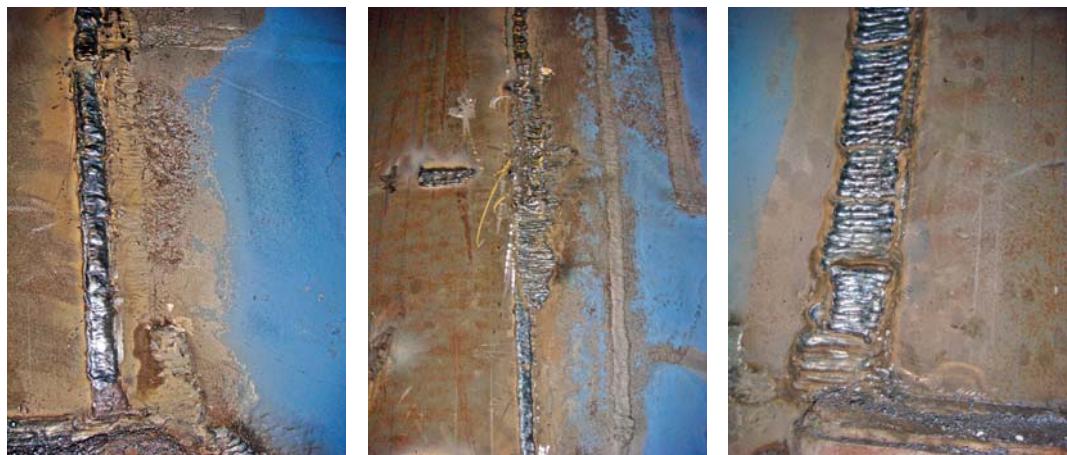
Typical repairs to a rudder that has suffered cavitation damage.

The repair usually consists of welding to restore and build up the surface where the metal has eroded or corroded away, followed by repainting. Plates may need to be entirely replaced. This usually takes the form of lengthy and expensive hot work performed in drydock. Alternatively, it can involve expensive, drawn out underwater repairs to the rudder to keep it functioning until the next opportunity to drydock the ship. Repairs done under water can only be considered a temporary measure since the steel and the welds must of necessity be left bare.

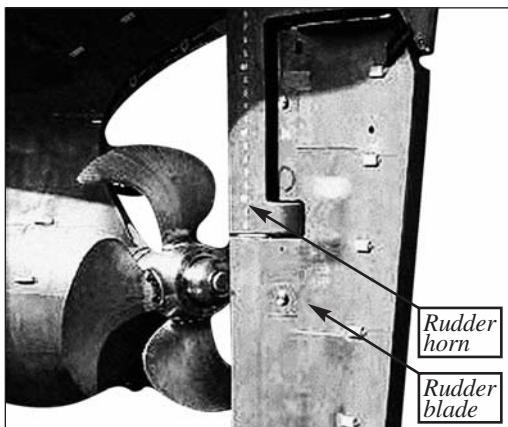
Semispade rudder

Much of the cavitation problems related to the gap between horn and blade (B and C in Figure 1) can be avoided by the use of full spade instead of a semi-spade type of rudder. Furthermore, by twisting the leading edge of the rudder it can be better adapted to the rotational flow from the propeller and thereby suppressing cavitation induced on the rudder (A in Figure 1).

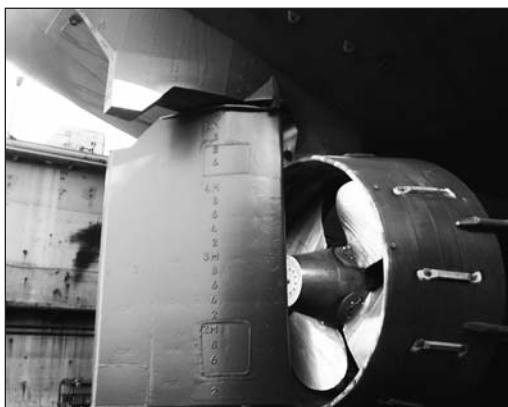
Full spade rudder

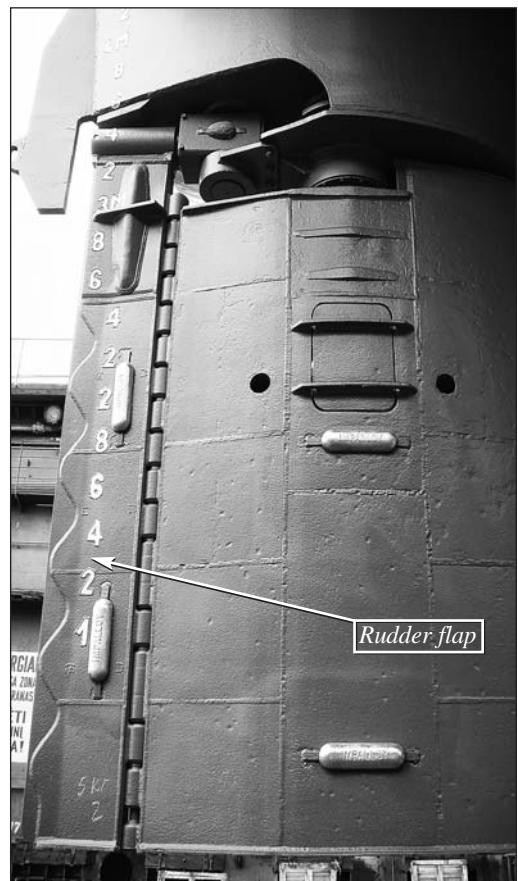
Flap rudder (full spade rudder plus a flap)

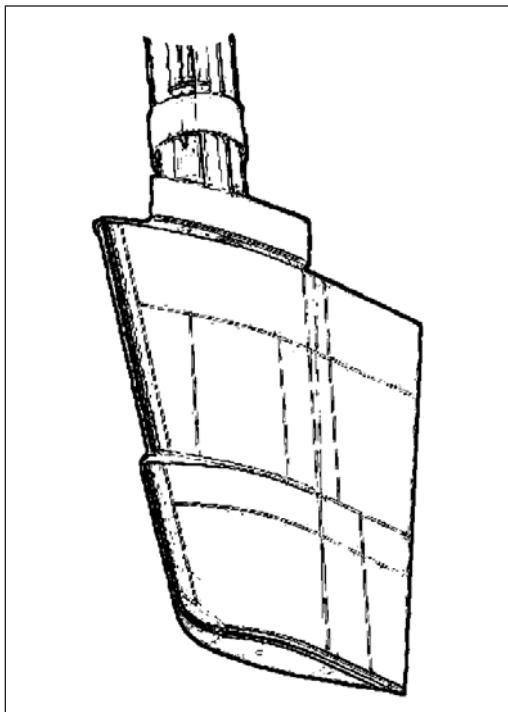
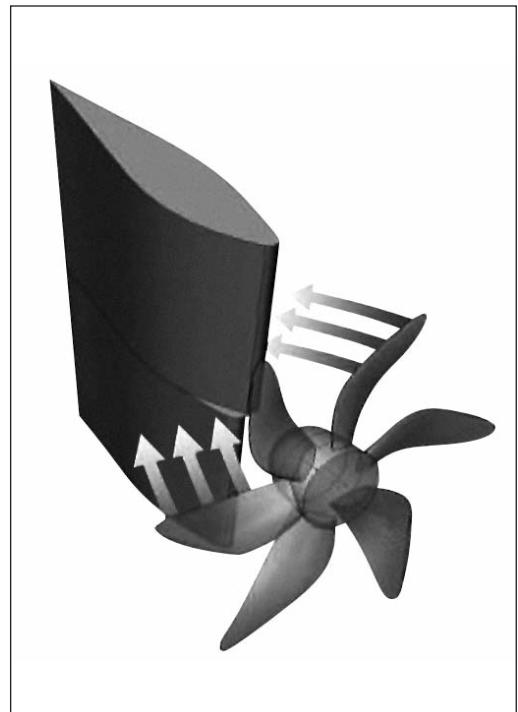
Twisted rudder

2. Redesign the rudder so that it is less affected by the flows and turbulence. Some inventors have developed a twisted rudder which is marketed and in use. The twist is an attempt to reduce the turbulence caused by the flow of the water from the rotation of the propeller by changing its angle of attack on the rudder. This has met with some success but has not eliminated the problem.

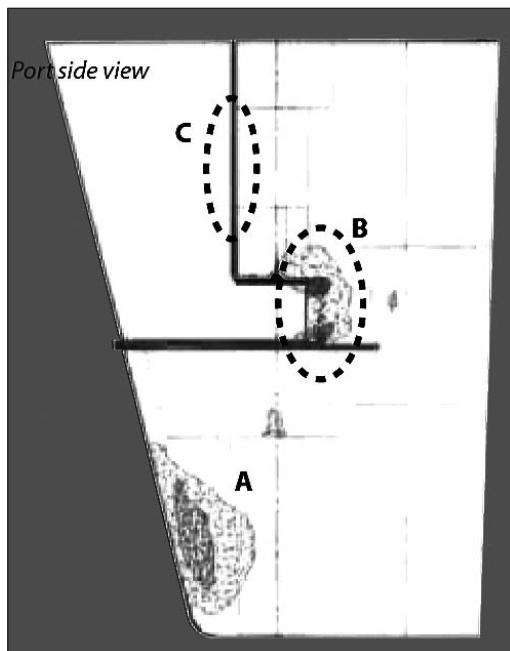
Figure 1 from the article "Cavitation Erosion Damage on Semispade Rudders" in *The Swedish Club Letter*.

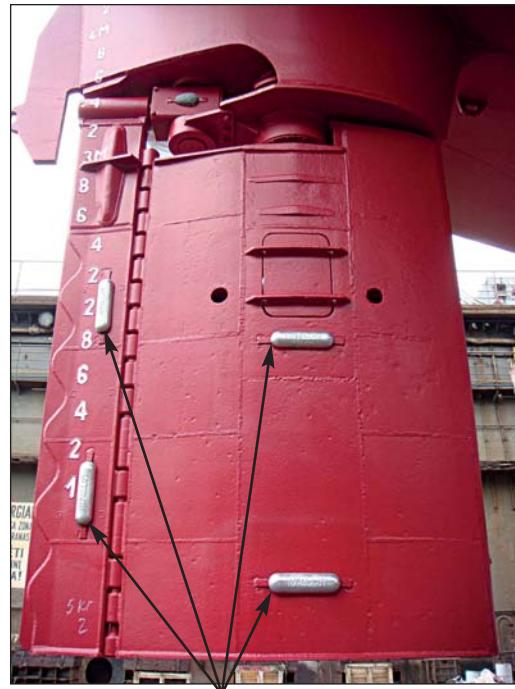
Sacrificial anodes on rudder blade and flap to help prevent or reduce corrosion.

As already discussed, however, the cathodic protection system is aimed at preventing or slowing down corrosion and has no bearing on cavitation erosion at all, thus it is an attempt to deal with a symptom, not with a cause.

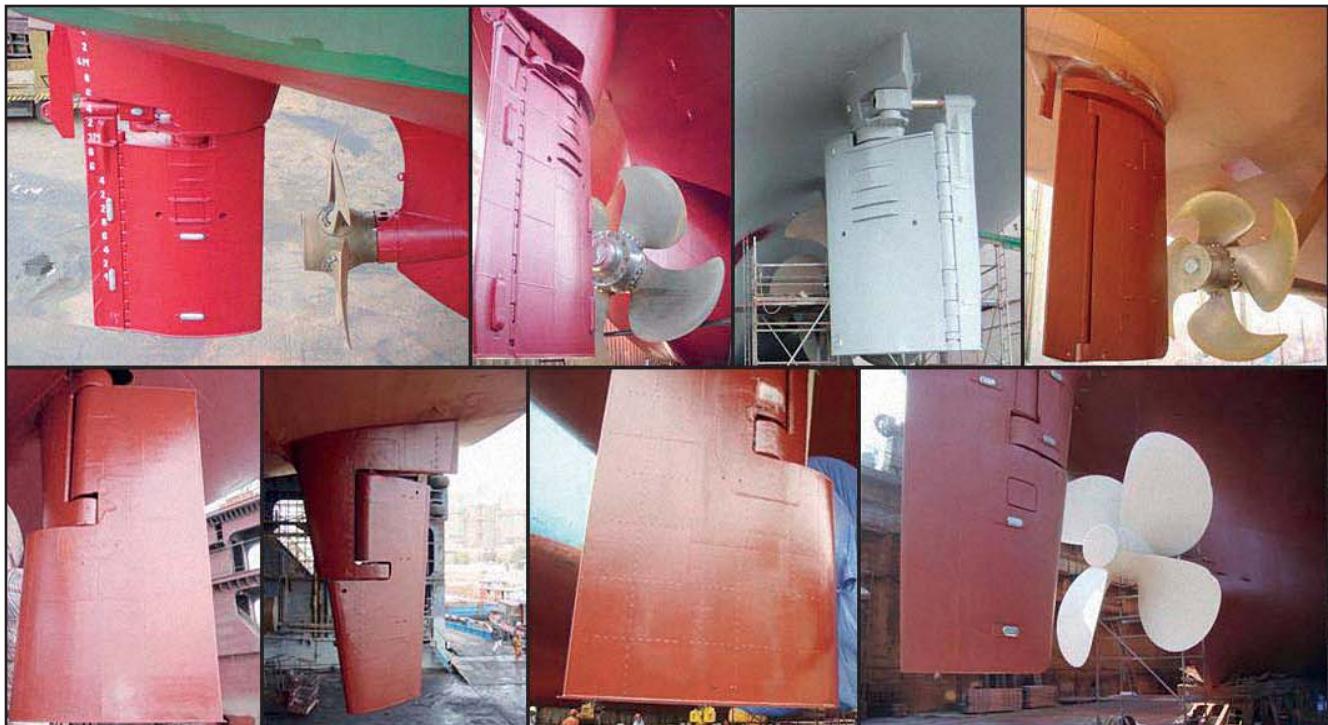
Some of the rudders coated with glassflake reinforced STC.

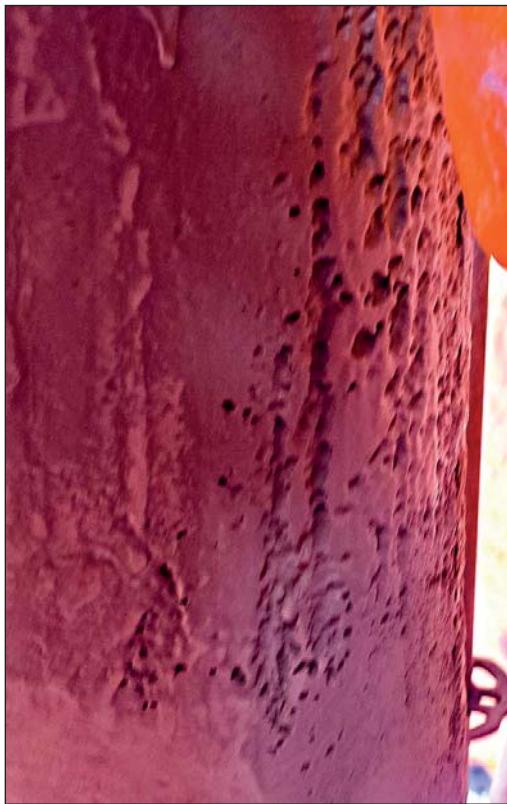
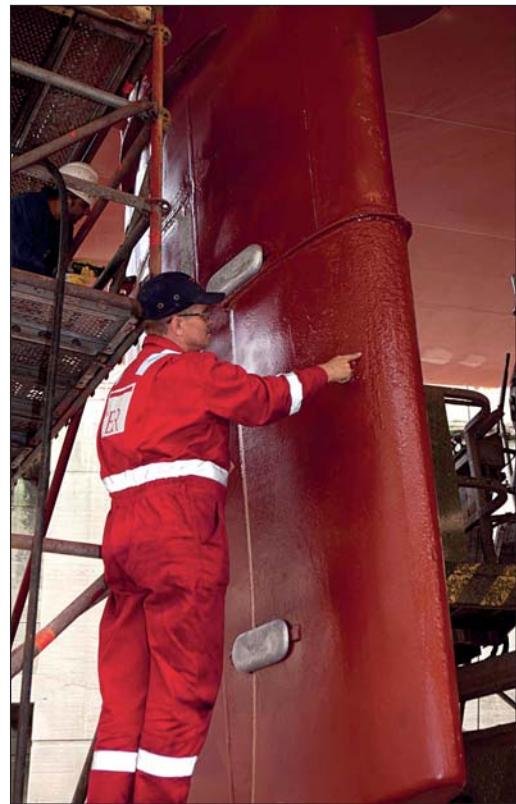
The rudder of the *Elisabeth Russ* when first coated with Ecospeed in 2004 (left). In the 2011 drydocking Superintendent Grzegorz Girjat points out the original cavitation damage which was simply coated over with Ecospeed in 2004 (right). No further cavitation damage has occurred to the rudder since the original protection at that time.

During that 2004 docking, Ecospeed [the glassflake reinforced STC used to protect the rudders now reformulated as a separate, special coating specifically for rudders and underwater gear, Ecoshield®] was applied experimentally on the *Elisabeth Russ*. The application was close to the end of the docking. There was only time to grit blast the rudder and apply two coats of Ecospeed. The pitting and damage from the cavitation was not repaired but the paint simply applied over it. This was the test.

The trial was successful beyond all expectations. When the ship next came out of the water in 2007 it could be seen that, despite the last minute application, no further cavitation damage had occurred.

coated, in 2011, confirms that the original Ecospeed protection applied in 2004 is still holding firm and the rudder is intact, free from cavitation damage.
