TundRA 3200 icebreaking tugboats now fully protected with our coating systems

Two Robert Allan Ltd. designed icebreaking tugs constructed at Turkey's Sanmar Shipyards have been protected with our coating system. The underwater hulls of *Selene* and *Helios* were coated with Ecospeed, the topsides with Ecolast and the azimuth thrusters with Ecoshield.

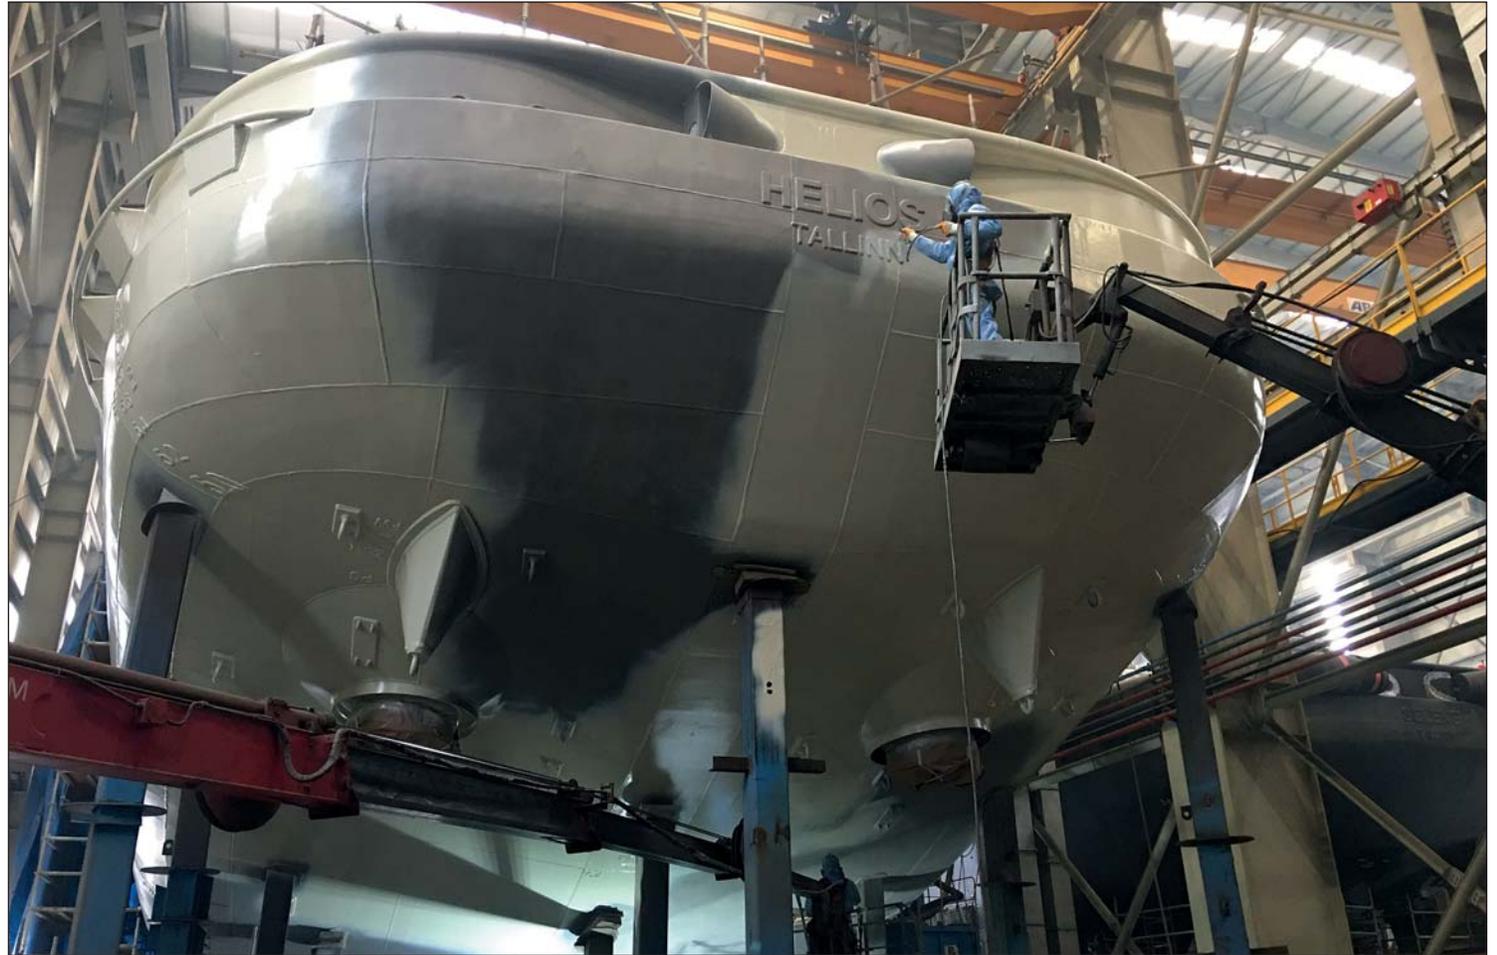
Application of first Ecospeed layer on icebreaking tug Helios.

Experience has shown that **Ecospeed** stays on the hull longer and resists the ice far better than the most generally used specialized ice coatings. Ecospeed remains bonded to the ship's plates even as they flex and bend under ice pressure and impact.

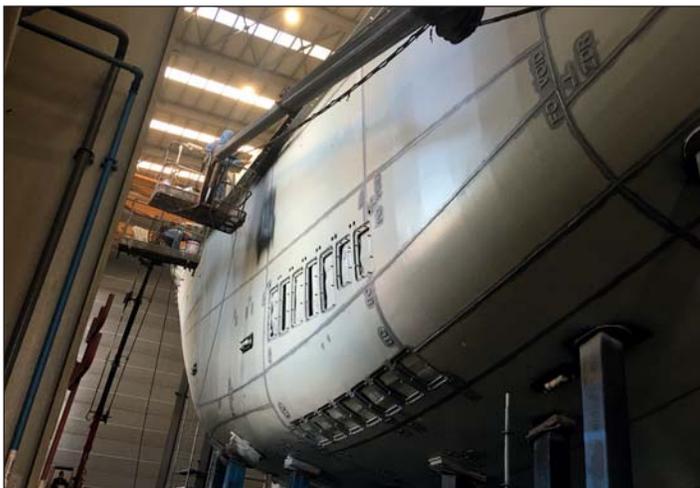
Application of Ecolast on m/v Helios.

Because the topside of these tugs also needed extra protection against ice, **Ecolast** was applied to this area of the vessels. This coating is ultraviolet (UV) light resistant and preserves its color while at the same time offering the corrosion and abrasion protection our coatings are known for. Regular coatings will quickly lose their original color when exposed to the ultraviolet radiation present in sunlight.

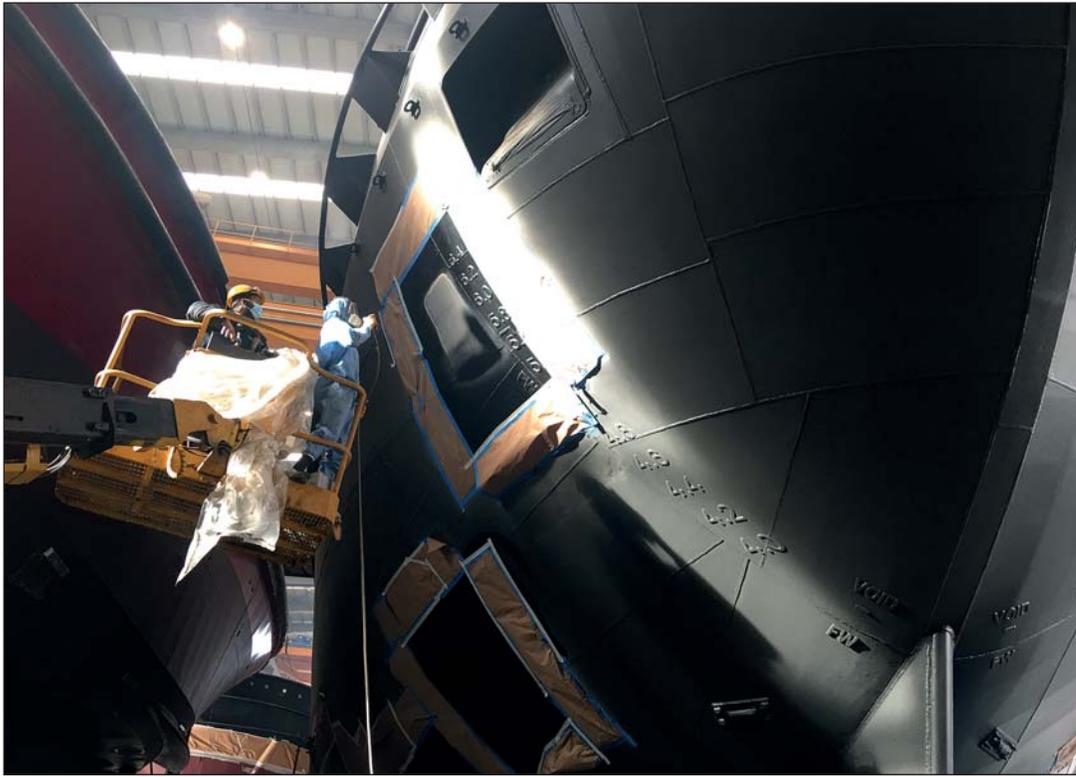
Application of the keel block areas blends in seamlessly with the rest of the coating.

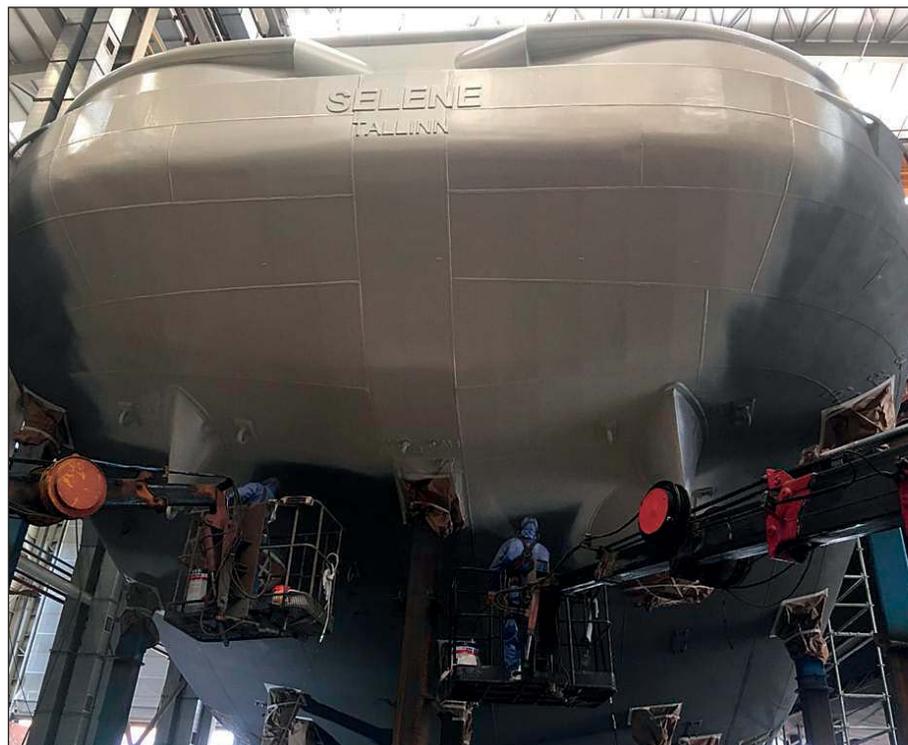
Ecospeed application on m/v Selene.

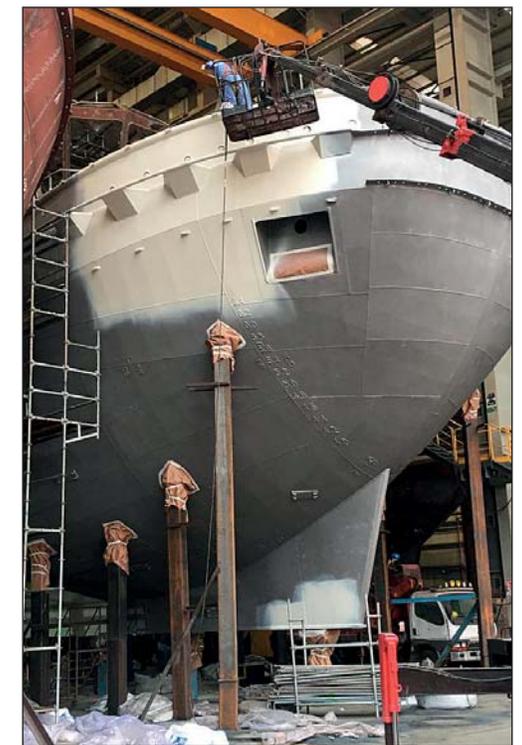
The topside of m/v Selene was coated with Ecolast.

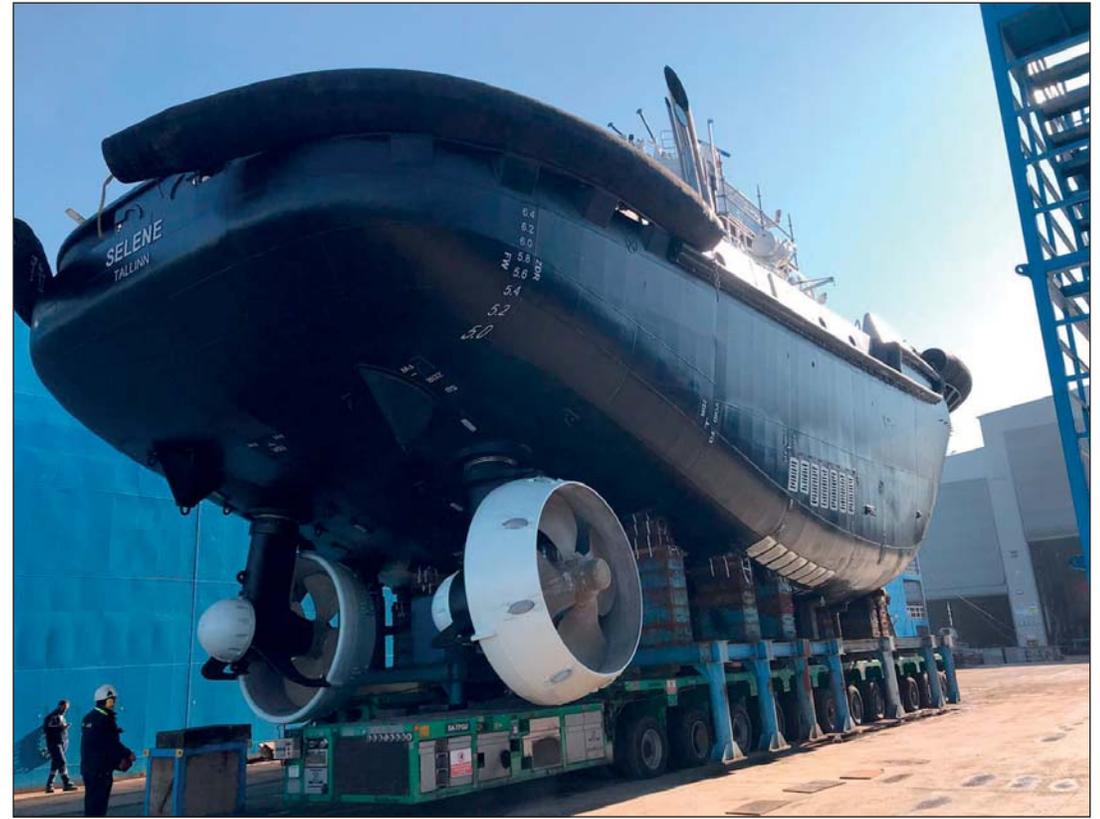
The azimuth thrusters of both vessels were coated with Ecoshield.

The azimuth thrusters of both vessels were given a lasting protection with our **Ecoshield** coating. This was done by the OEM prior to delivery. Ecoshield offers permanent protection against cavitation damage for rudders, bulbous bow, stabilizer fins, thruster nozzles and other underwater ship gear which needs special protection from corrosion.
