Biocide free 'antifouling' for ships

Emissions from the underwater coating 'Eco-speed'

English translation of WD report 2008.057, of 'Biocidevrije antifouling voor schepen, emissies vanuit de onderwater coating 'Ecospeed', dd.15 November 2008 from A. Wijga, E. Erdtsieck RWS ZL, J. Romeijn RWS ZH, R. Berbee, J. Tiesnitsch, S. Rotteveel, and L. Eibrink RWS WD.

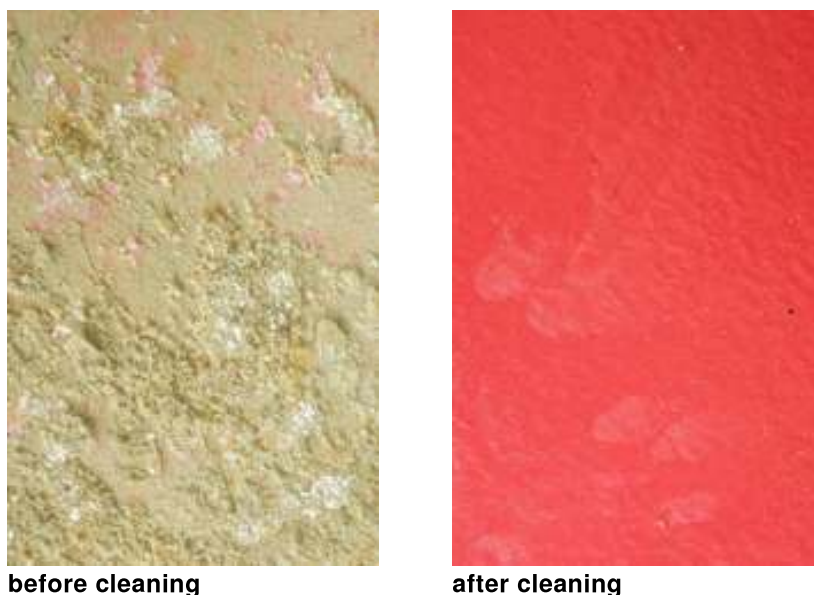
A test plate that was placed in the Marine Port of Zeebrugge for a year has been used to evaluate the cleaning. During cleaning, there was noticed that this plate was only coated at one side. The not-coated side was somehow rusty as a result of the corrosive action of the sea water. There was some fouling of sea organisms shown on the coated side. The cleaning is executed in distilled water in order to be able to detect possible release of heavy metals during the cleaning.

Figure 2.
Before and after cleaning of a plate from Zeebrugge (1 year contact in seawater)

The analyse of heavy metals was abandoned because one side was rusty, The rust can lead to too high metal concentrations, which could result in inaccurate results.

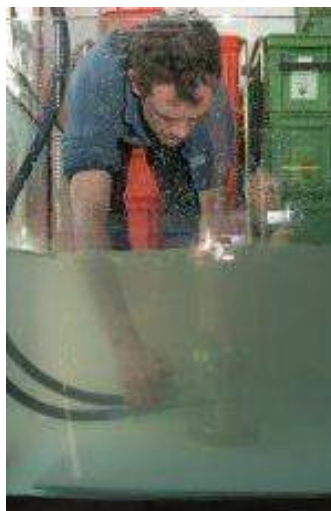
3a polishing

Figure 3 a en b
View of polishing and cleaning

The samples taken after polishing are shaken and then observed whether the solids settle rapidly. This was not the case. The suspended solids consist of very small particles that more or less keep floating. It seems that the particles after a longer period (1 week) somewhat start to conglomerate. Some flocculation occurred. Removal of the small particles coming from the polishing by sedimentation seems from a practical viewpoint not to be a valid option.
