Ship Repair Newsletter

Issue No: **1684**

Date: **20th October 2017**

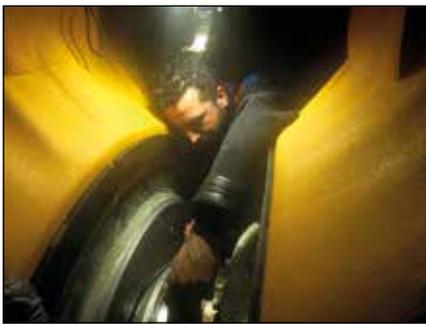
Underwater stern tube seal repairs

Damaged stern tube seals may cause severe oil leaks. By replacing the seals on-site and underwater, Hydrex avoids down time as seal repairs can be performed during cargo operations.

We do this by creating a dry working environment around the shaft with our flexible mobdocks. They fit all sizes of seal assembly and can be mobilized quickly to locations around the world.

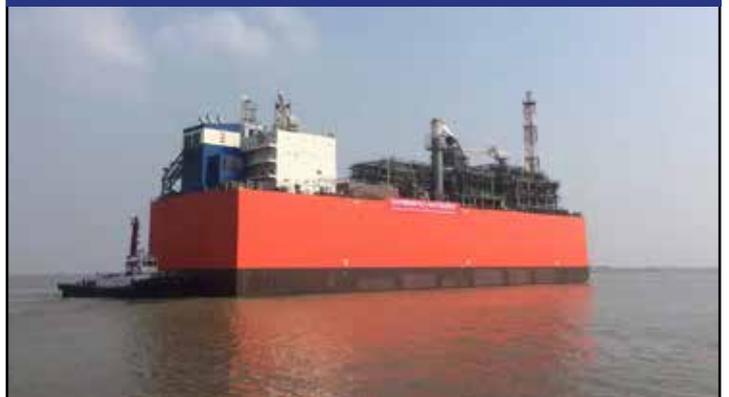
Exmar has opted for Subsea Industries' hard coating technology for its barge-type floating assets

Like the first project, the FSRU was built in blocks which were coated prior to assembly. Weld seams and inaccessible areas were coated after the unit was assembled.

Prior to application, preparation work has to be carried out to ensure a structural profile of at least 75µm (SA2.5 or better). Ecolock is then applied but requires no primer or other type of coating. Typically, just two 500 µm coats are applied with minimum curing time of three hours between each application.
