# Rudders that do not need recoating

Hydrex's Ecospeed rudder coating claims to offer lasting defence against the effects of cavitation

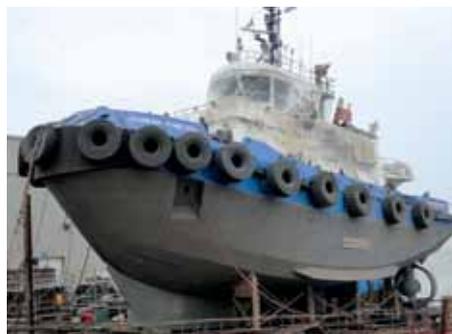
Hull of *Ocean Raymond Lemay* blasted ready for painting

Clearly any paint is only going to be as good as the surface it is attached to, and that is the key to any type of hull coating. Preparation is just as important as the coating itself. Many owners have discovered that after spending tens of thousands of dollars on a new paint job in drydock, that months or even weeks down the line the paint is starting to flake or even peel off in sheets. Surface blasting preparation, rust and dust, and humidity all play a key role. **MP**

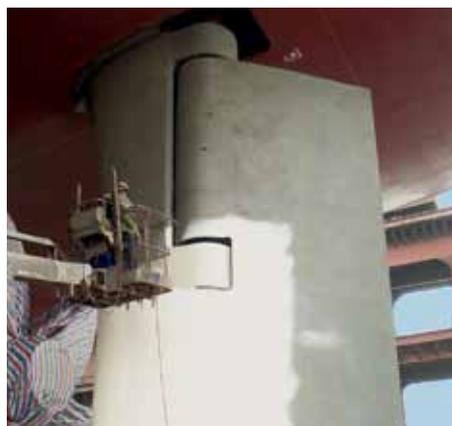
Good blasting preparation is vitally important before painting

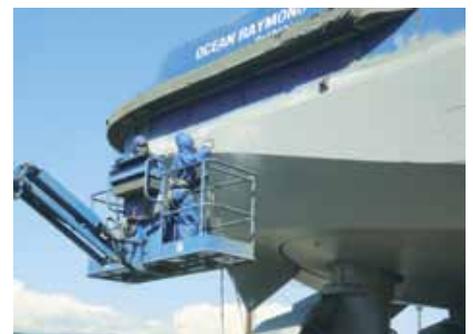
Paint crew applying top coat of Ecospeed

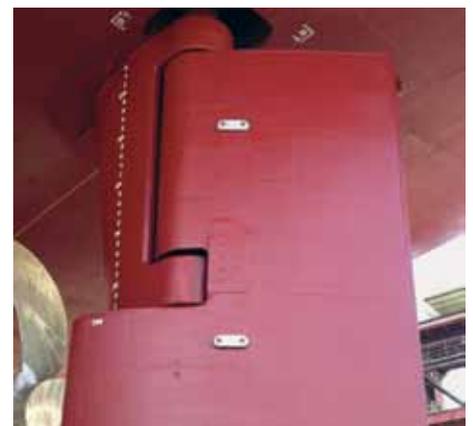
The finished coat should remain intact well past the next docking
